# STUDY OF BEHAVIOR OF GRILLAGES IN ELASTIC AND PLASTIC RANGES

## FINAL REPORT

Contract No. N00024-67-C-5356  
Project Serial No. S-F013 C3 01 Task 2050  
SwRI Project No. 03-2101-01

for  
Naval Ship Systems Command  
Department of the Navy  
Washington, D. C. 20360

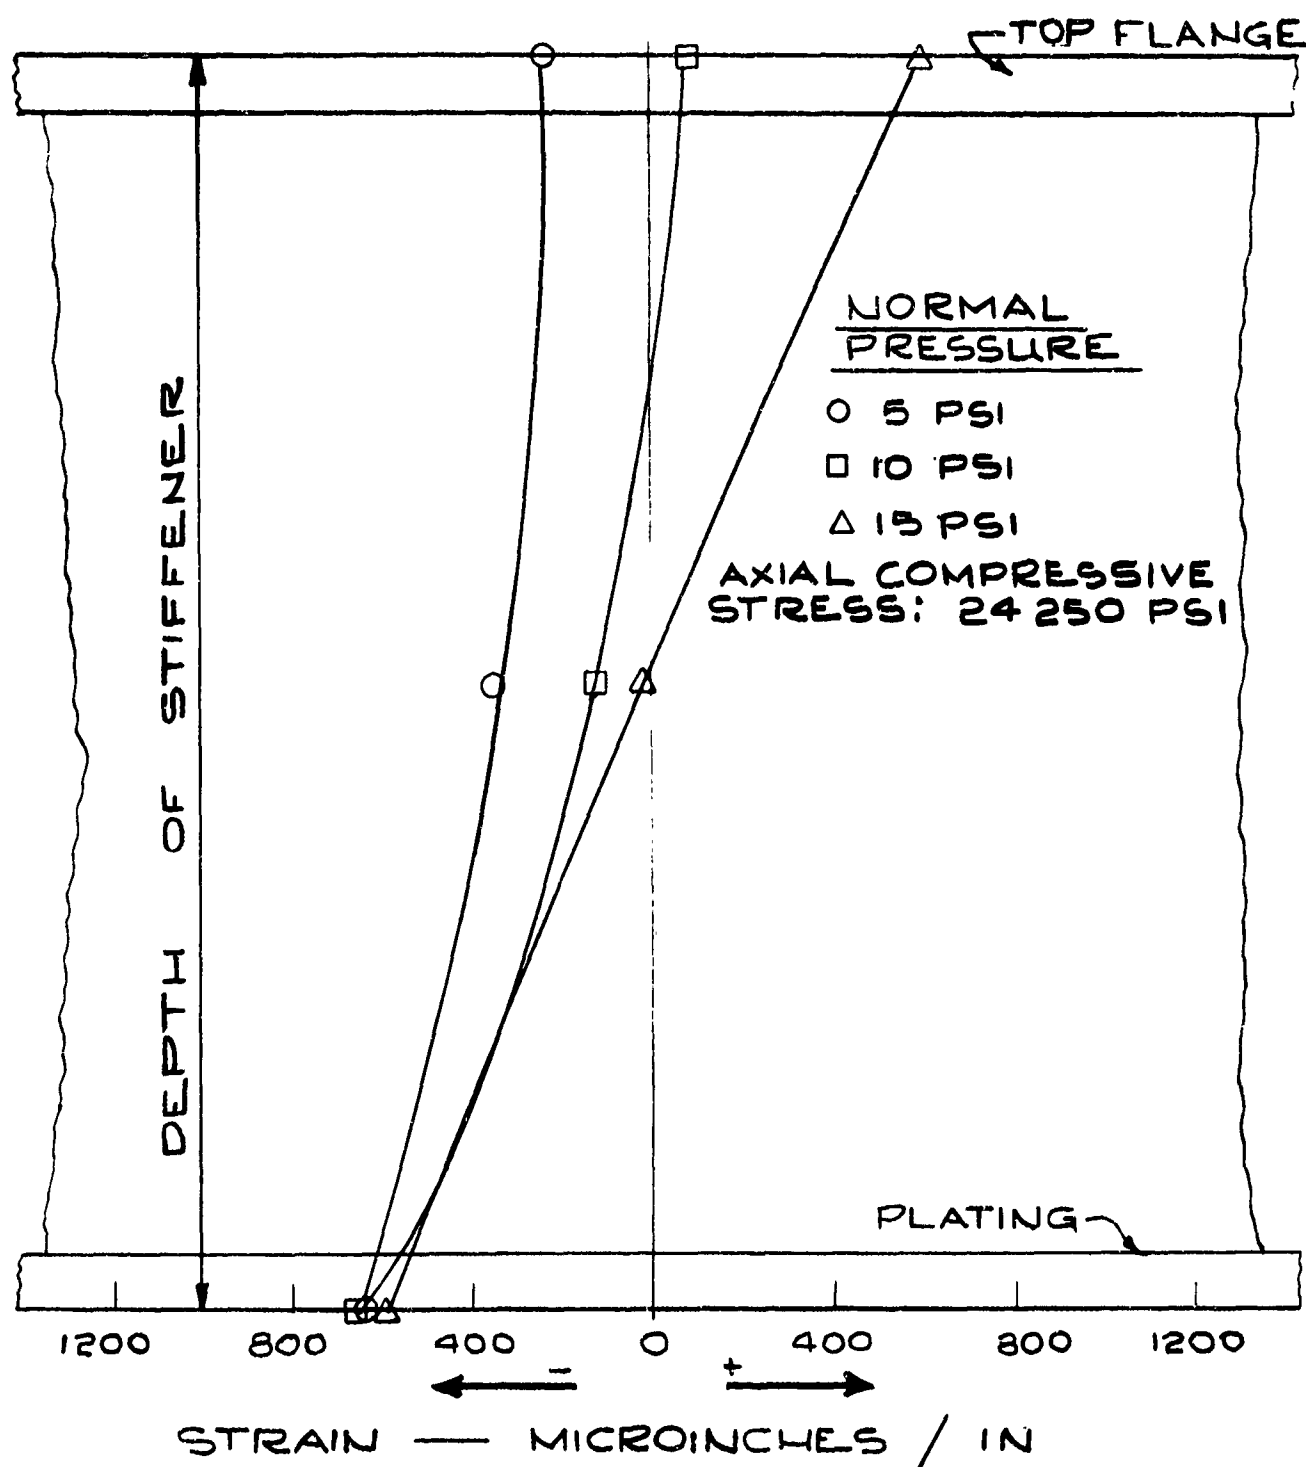
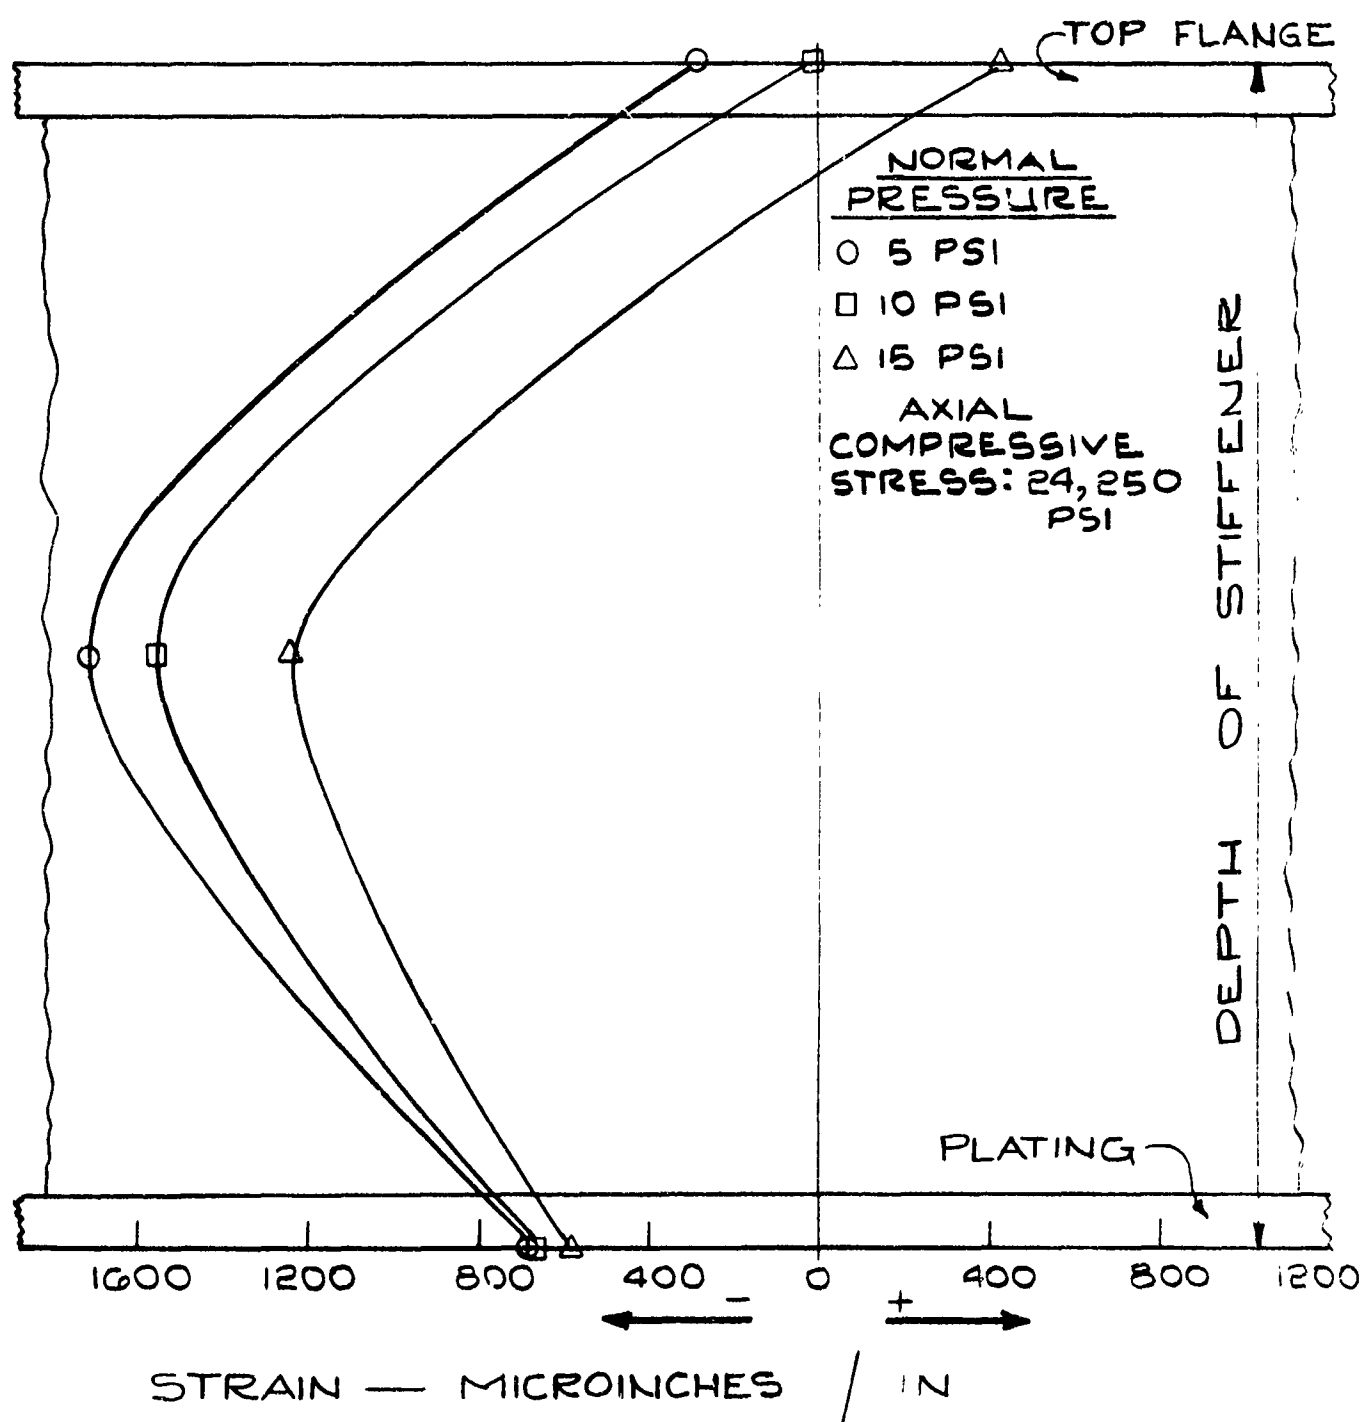
Figure 22(a) gives the strain distribution in the grillage longitudinals at the axial stress of 24,250 psi. It will be noted that the strains in the top flange of the longitudinal have changed little from their corresponding values in Figure 21. The strains in the "bottom flange," however, have increased noticeably. Again, at the maximum pressure of 15 psi the strain distribution is linear (almost perfectly linear in this case), with the geometric center of the section experiencing zero strain.

FIGURE 22(a). LONGITUDINAL STRAIN,  $\epsilon_x$ , IN THE LONGITUDINAL "A"  
27" FROM THE CENTRAL TRANSVERSAL

FIGURE 22(b). LONGITUDINAL STRAIN,  $\epsilon_x$ , IN LONGITUDINAL "A"  
18" FROM THE CENTRAL TRANSVERSAL

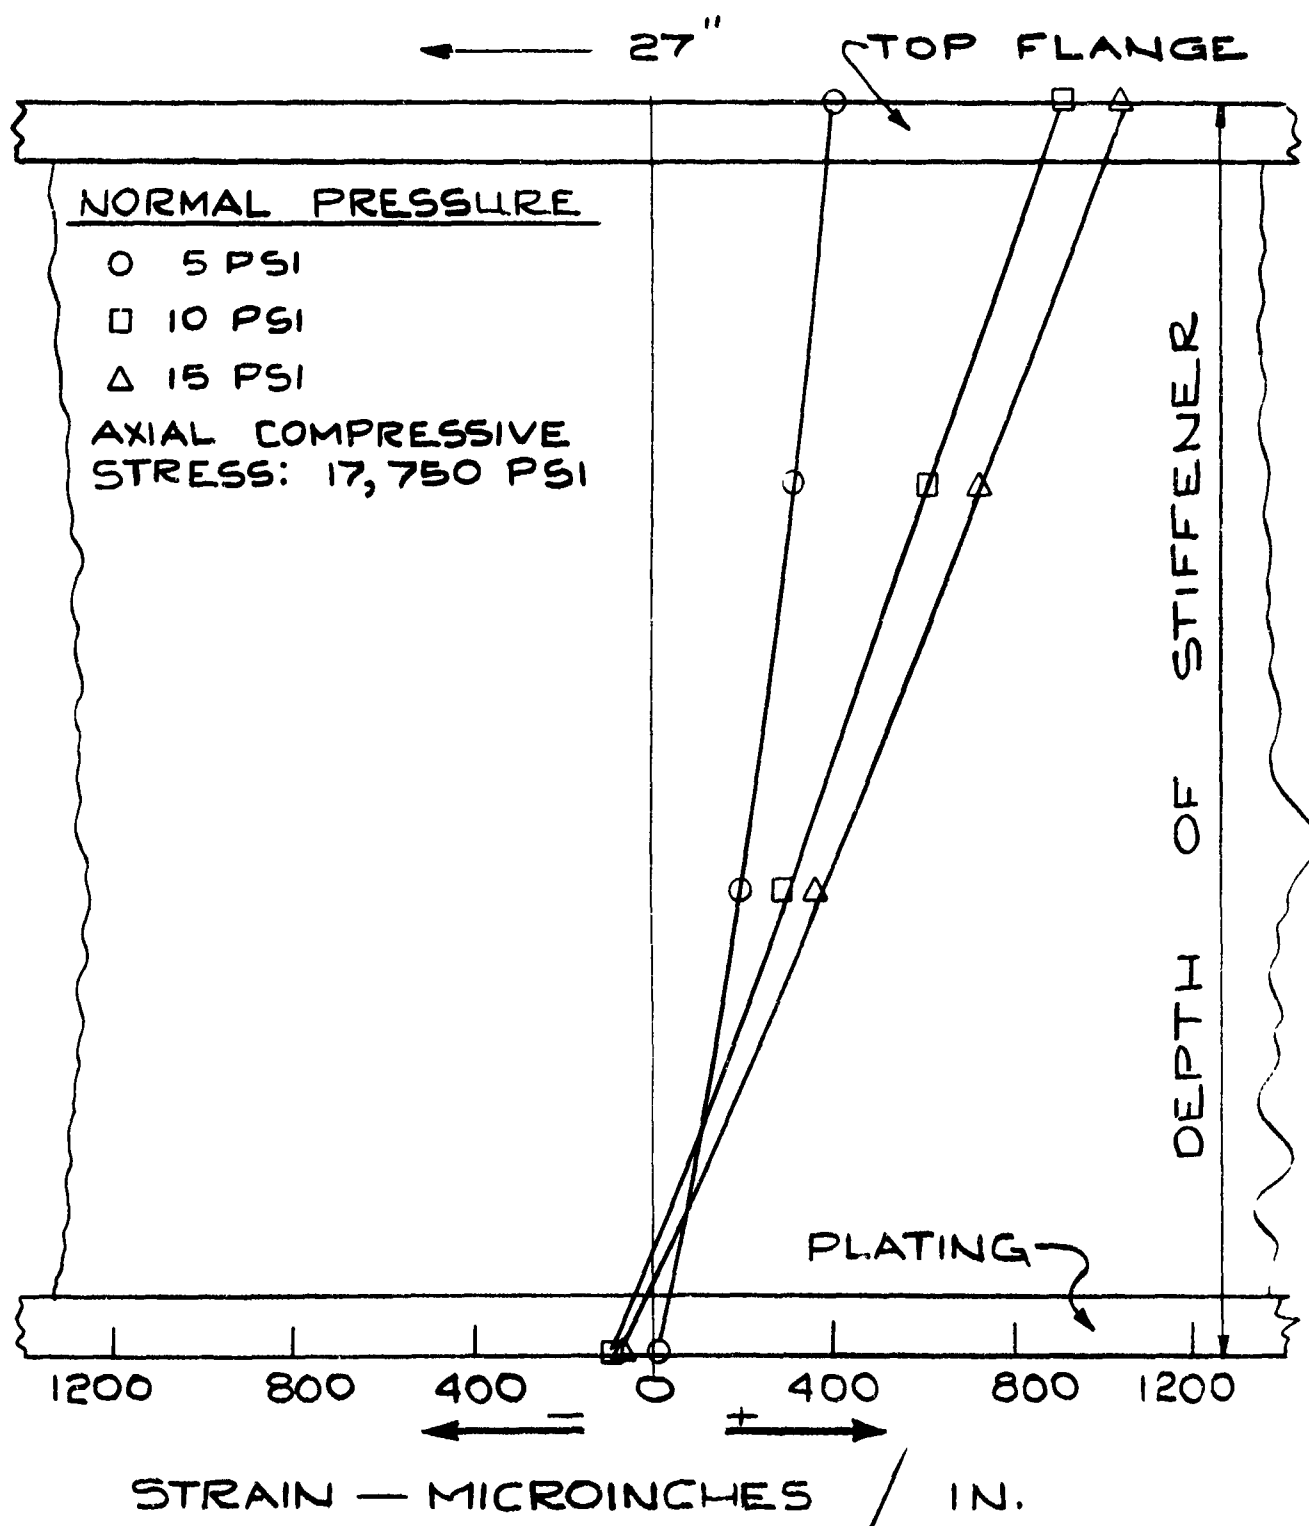
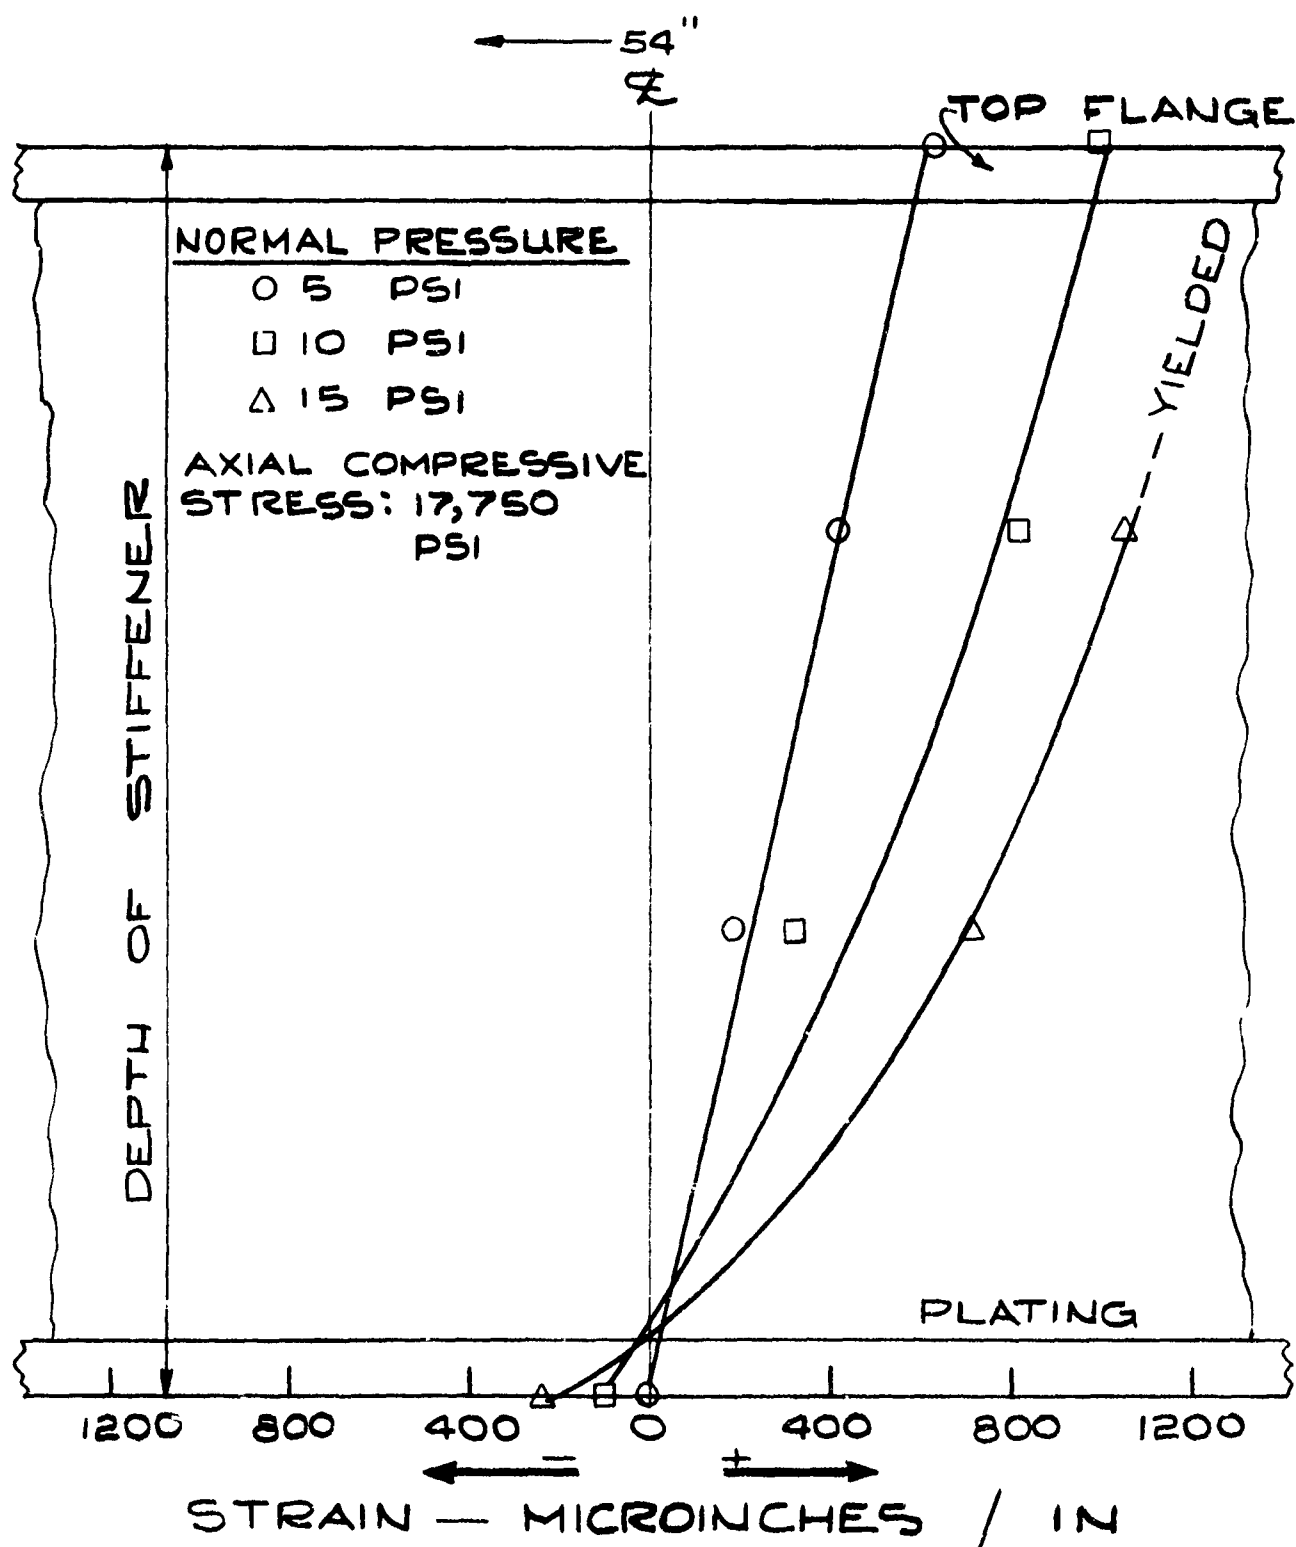
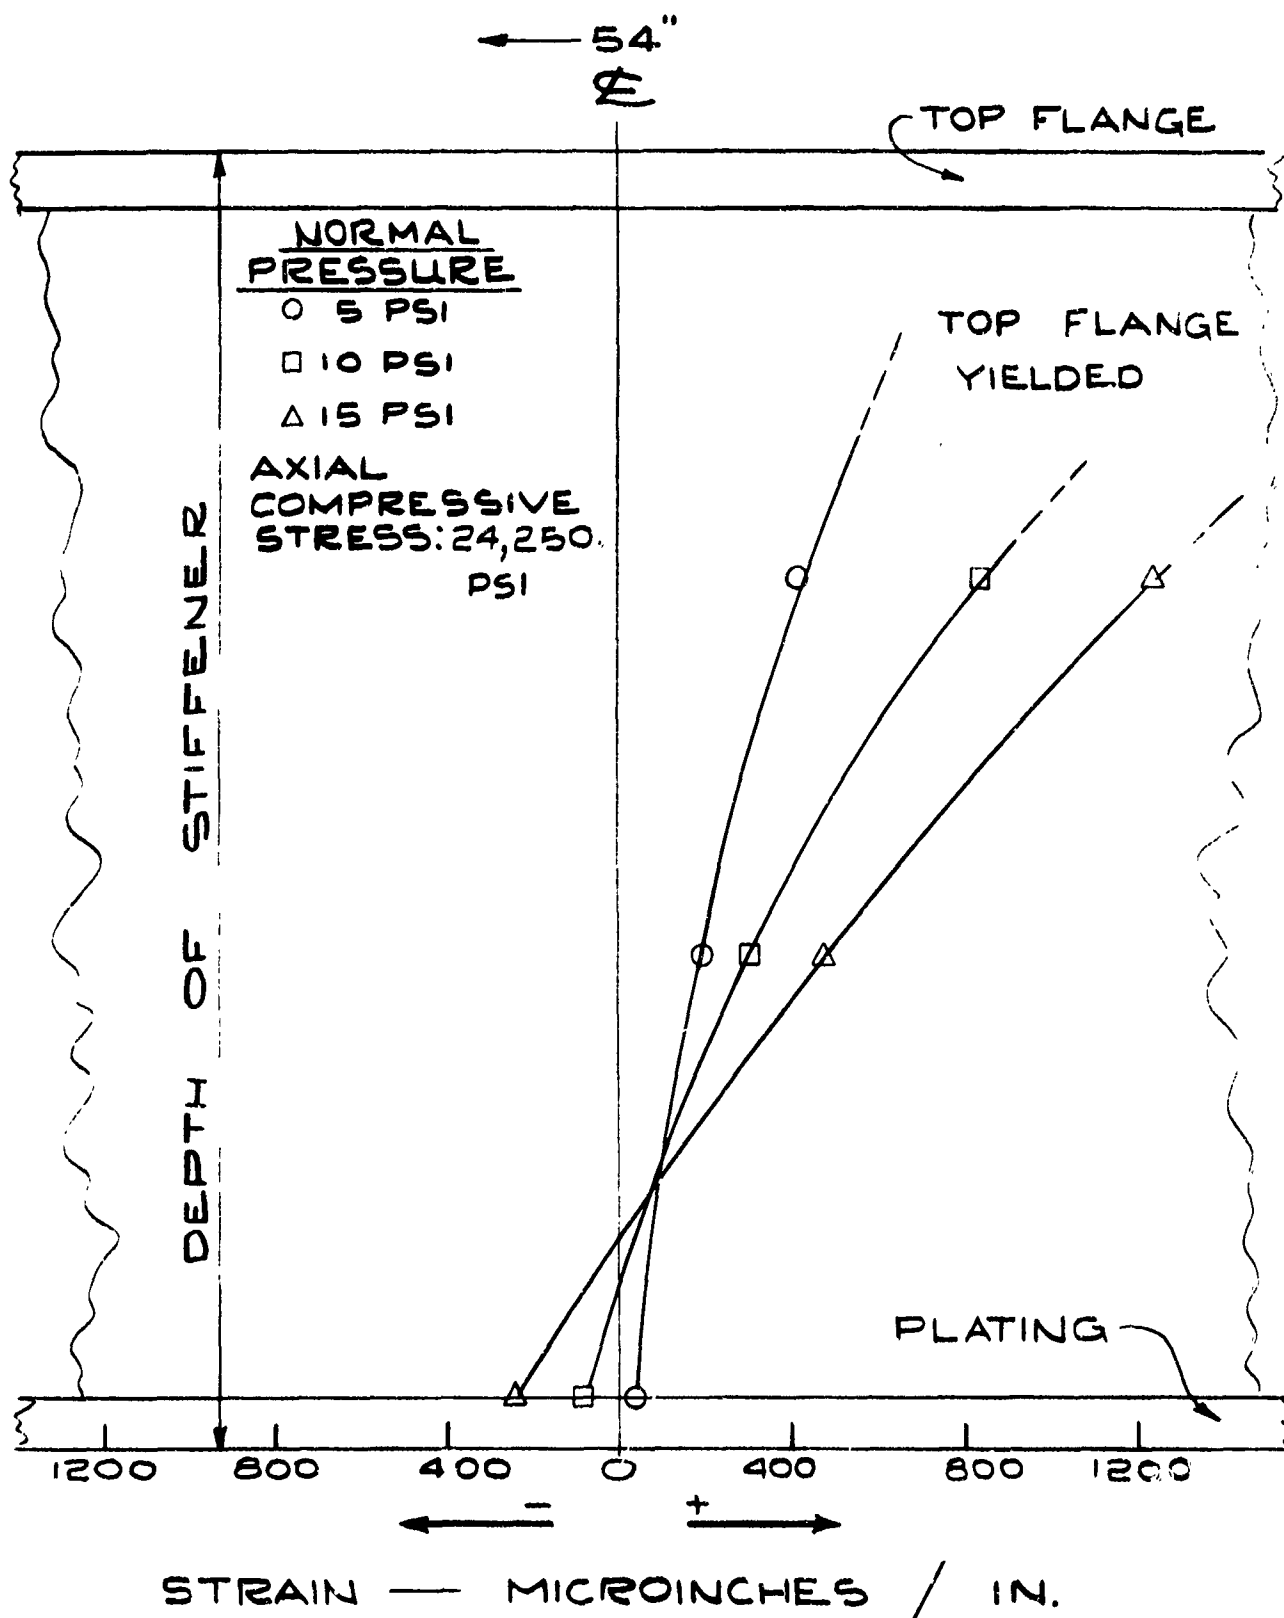
The strains at various sections along the central transverse stiffener are given in Figures 23 and 24. Strains 7 inches from the side of the grillage could not be plotted with any accuracy because, apparently, there was considerable strain concentration at this section and the resultant strain records were unsatisfactory.

It will be noted that both at 17,750 psi and 24,250 psi axial stress, the strain distribution was nearly linear 27 inches from side of grillage

FIGURE 23(a). STRAIN IN THE CENTRAL TRANSVERSAL 27" FROM THE GRILLAGE EDGE

FIGURE 23(b). STRAIN IN THE CENTRAL TRANSVERSAL AT THE GRILLAGE CENTERLINE

FIGURE 24(a). STRAINS IN THE CENTRAL TRANSVERSAL 27" FROM THE GRILLAGE EDGE

FIGURE 24(b). STRAINS IN THE CENTRAL TRANSVERSAL AT THE GRILLAGE CENTERLINE

and, at low pressures, this linearly was maintained to the longitudinal centerline of the grillage. Moreover, at all pressures, the zero strain axis is close to the bottom plating. This shows that the effective width of plating is virtually unaffected by either the axial load or the normal pressure. Thus, the behavior of transversals, because of the absence of axial loads, is quite different from that of the longitudinals.

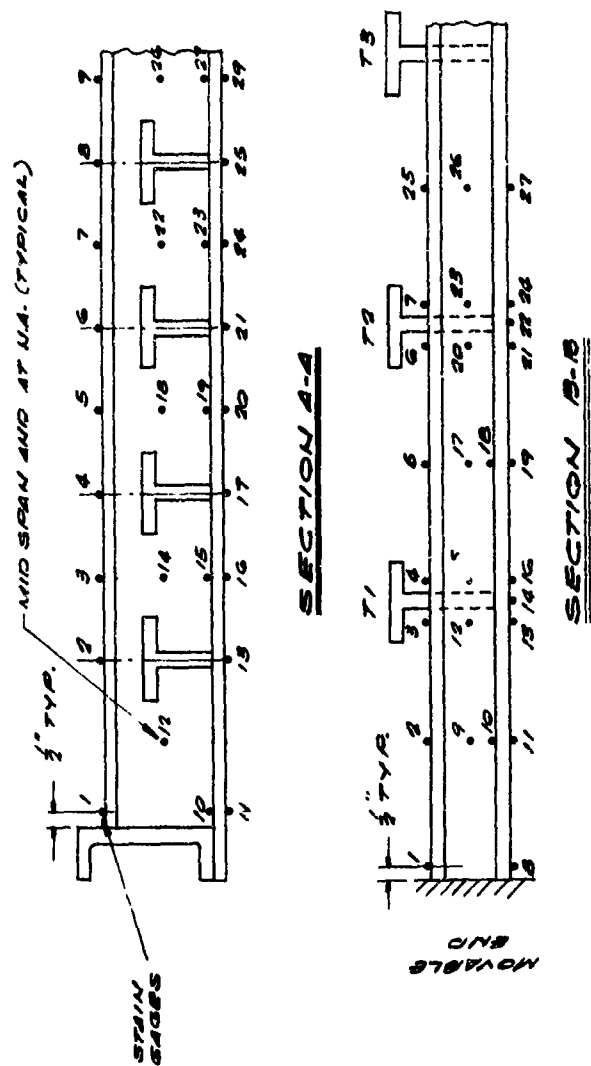
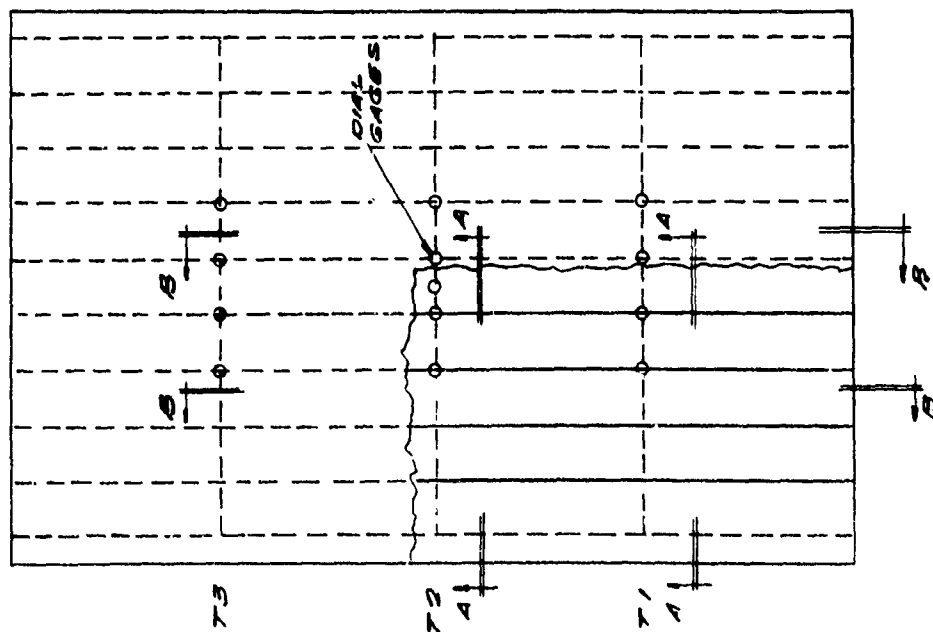
The proposed instrumentation for Specimen No. 2 is given in Figure 25 wherein, it will be noted that the total number of suggested strain gages is 144. Although this represents a considerable reduction from that used in Test No. 1 of this report, the number is felt to be quite sufficient. For Specimen No. 3 the instrumentation would be similar to that in Specimen No. 2 but the total number of strain gages would be

FIGURE 25(a). INSTRUMENTATION PLAN FOR PROPOSED SPECIMENS 2, 3 AND 4

FIGURE 25(b). STRAIN GAGE KEY
